AFWAL-TR-79-3095
VOLUME II

ADVANCED RESIDUAL STRENGTH DEGRADATION RATE
MODELING FOR ADVANCED COMPOSITE STRUCTURES
VOLUME II - TASKS II AND III

Lockheed-California Company
Burbank, California

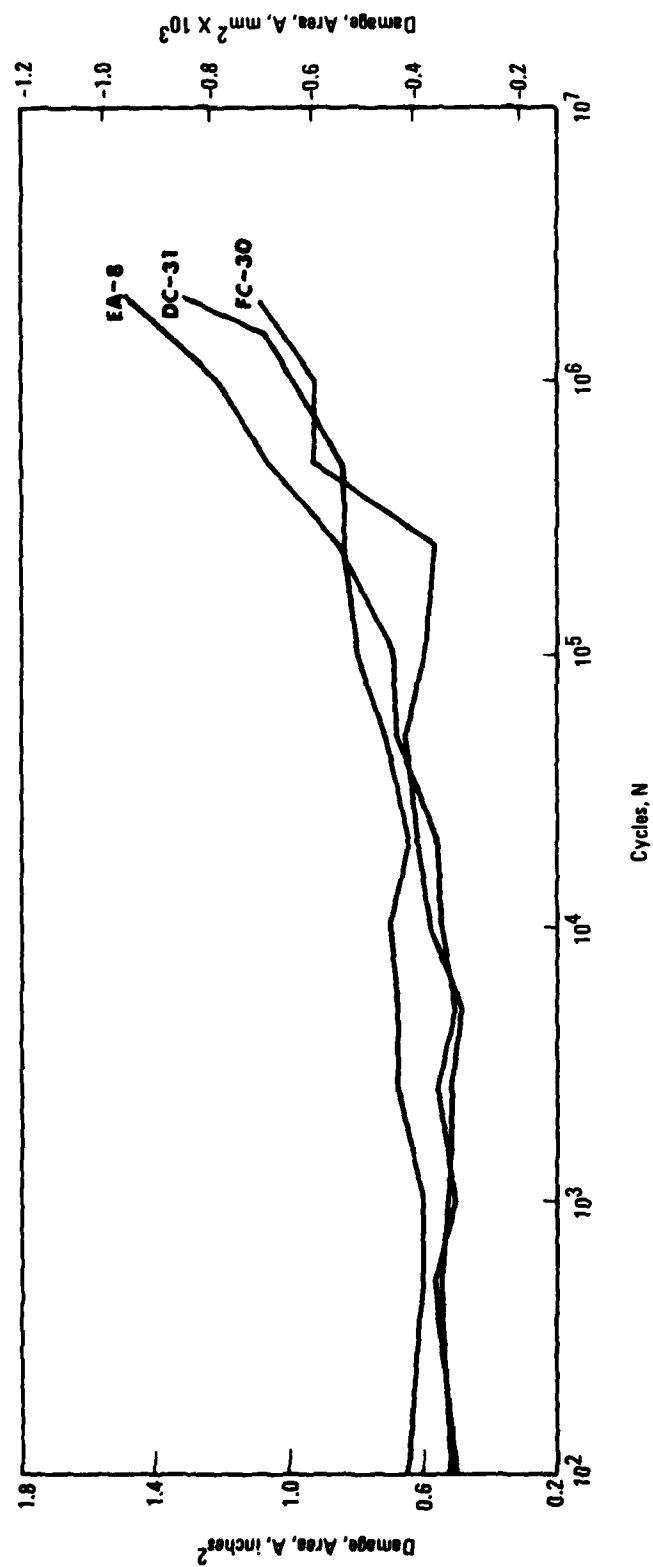
Figure 95: Area Damage Growth Behavior for 32-Ply Specimens, Case B ($R = -0.3$).

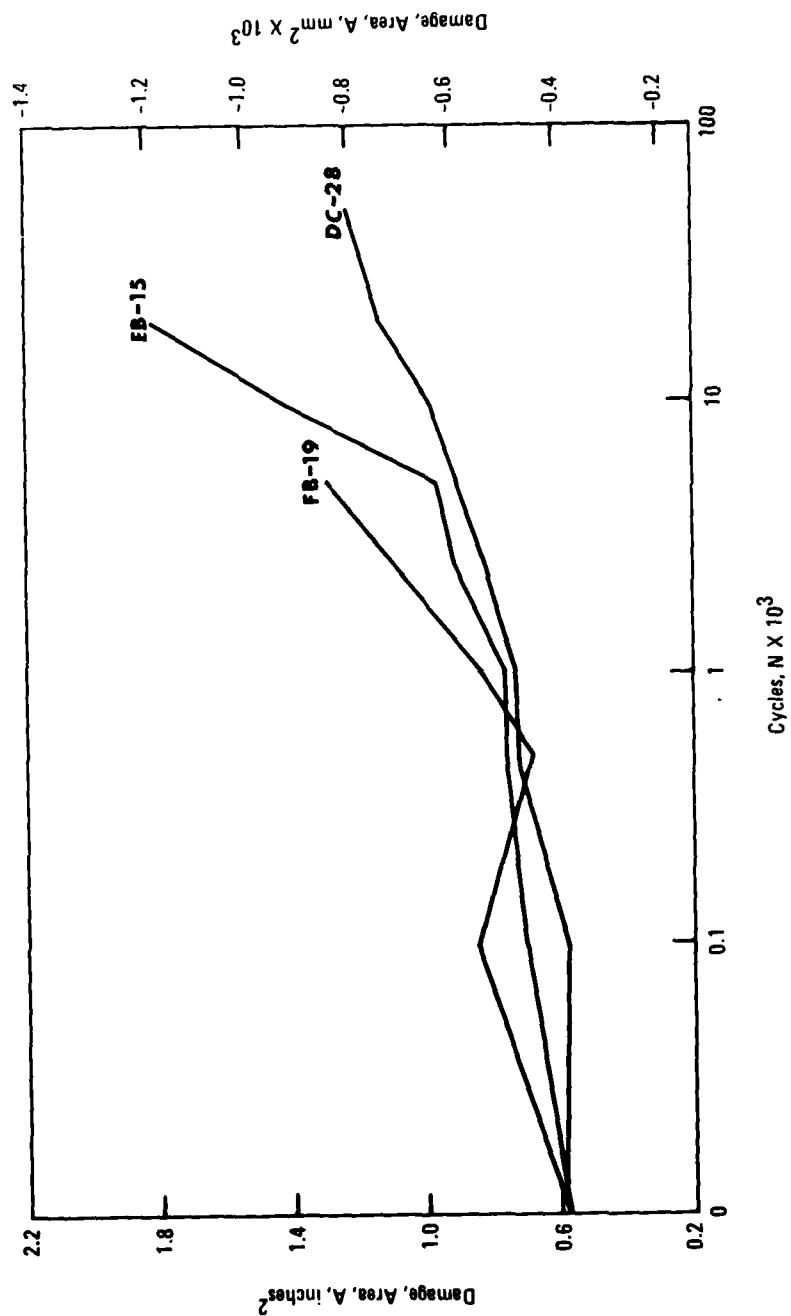
Figure 96: Area Damage Growth Behavior for 32-Ply Specimens, Case C (180°F).
